TESTS OF LEAD-BRONZE BEARINGS IN THE DVL

BEARING-TESTING MACHINE

Luftfahrtforschung
Vol. 16, No. 7, July 20, 1939
Verlag von R. Oldenbourg, München und Berlin

TECHNICAL MEMORANDUM NO. 943

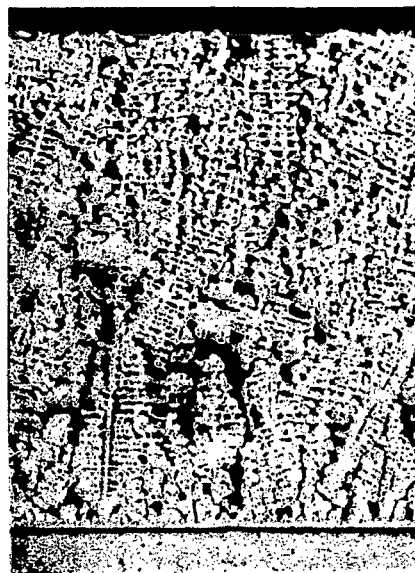
Figure 5.- Lead-bronze alloy 20 IV
(16.8% Pb); etched with
weak acid. Magnification 50X.

Based on the existing test and experience, high-performing lead-bronze bearings should show a uniform lead distribution with fine globular grain of the inclusions. As illustrated in figures 3 to 15 (showing only 40 mm long etched cuts of the materials), this condition is present only in the castings of low lead content as 20 I to 20 IV. Still, these illustrations do not show the regular or fine-globular, or the fine dendritical characteristics, of the foreign bronze-lead alloys shown in figures 16 and 17. All other castings rich in lead show more or less large zones of inclusions or concentration of lead. Alloys 30 I, II, and IV, also 40 II and IV show particularly strong inclusions which can be noticed even with the naked eye on the running surface of the bearing. (See figs. 18 and 19.) A relationship of lead distribution to impurities and the contents of inclusions (nickel), respectively, is unimportant. It seems, therefore, that changes in grain are due mostly to different castings and cooling conditions. Even with different alloys from the same source, great variation of grain structures can be noticed. However, the manufacture of castings with a low lead content seems to give fewer difficulties.

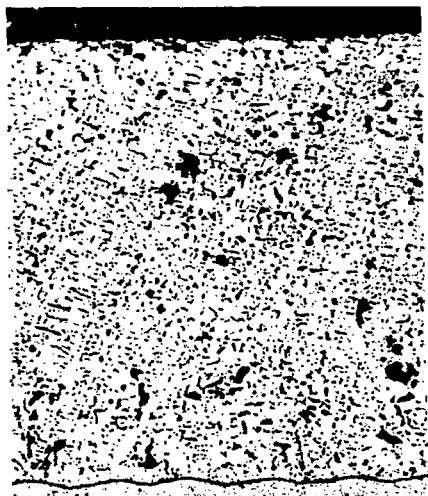
Figure 4.- Lead-bronze alloy 20 III
(22.6% Pb); etched with
weak acid. Magnification 50X.

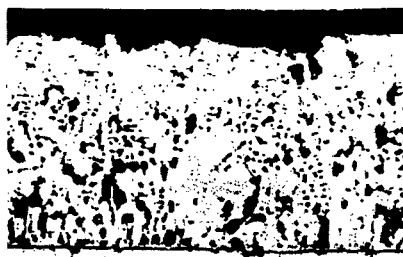
Figure 6.- Lead-bronze alloy 20 V
(23.4% Pb); etched with
weak acid. Magnification 50X.
State after test run.

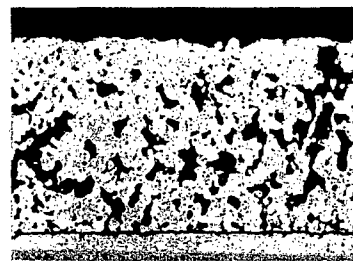
Figure 15. Alloy 40 V
(38.3% Pb) Mag. 50X.
State after test run.

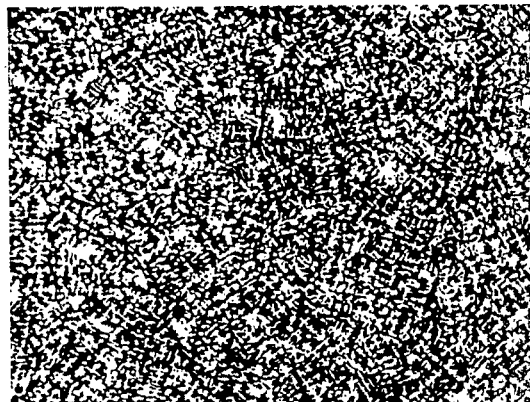
Figure 16.- Uniform and fine-globular lead distribution of a foreign-made lead bronze alloy. (70.70 Cu., 28.98 Pb.; .12 Ni.; .18 Fe;) Hardness $2.5/15.625/180 = 22\text{kg/mm}^2$. Mag. 50X.

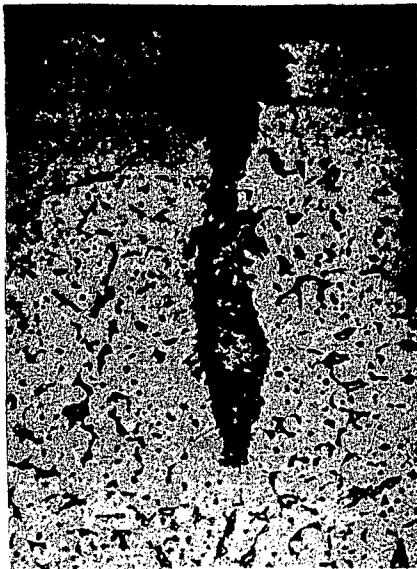
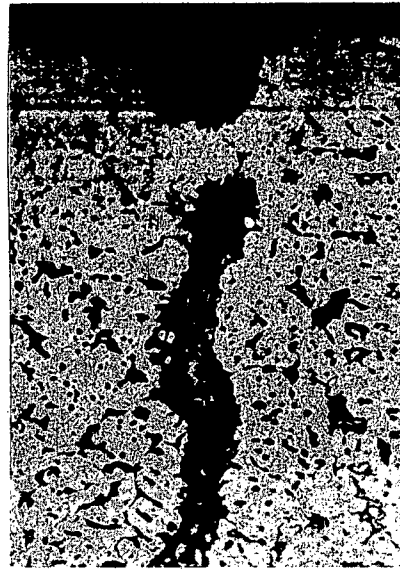
Figures 31, 32.- Alloy 30 I (test bearing 933). Shows crater-like enlargement of pores in the running surface in the end zone of lead segregations. (The micro-photographs show cuts parallel to the direction of rotation so that the cavities do not illustrate scorings in the surface.) In illustration 32, the cutting surface is made close to the entrance of the segregation into the running surface. Magnification 200X.

the oil. Because of an eddy effect, the slowly formed cavities are more and more enlarged until finally even the base material is attacked on the border of the pores. Figures 31 and 32 show craterlike expansions of pores which have been created in the above manner. How strongly the load faculties of a bearing are influenced through lubricating disturbances caused by pores can be seen especially in the test results of bearing 332 which showed large pores only on one half of the bearing. (See also fig. 30.) Arranging these pores into the load zone, the maximum load was found after long running time under dynamic load to be 440 kg/cm^2 . After turning the bearing for 180° , a maximum load of 500 kg/cm could be reached very quickly, so that in this case the actual load limit could be estimated to be substantially higher.

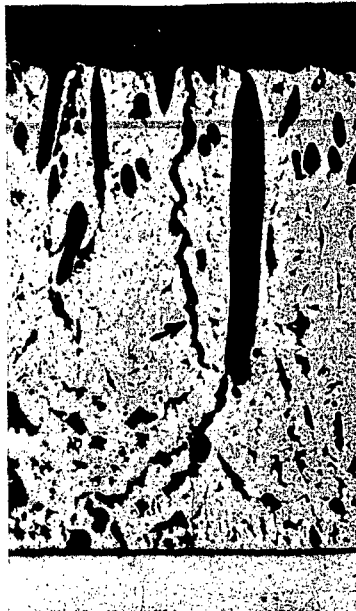
Figures 38, 39.- Cracks within the alloys
illustrated in figures 34
and 35 made of alloys 20 I and 30 I.
Magnification 50X.

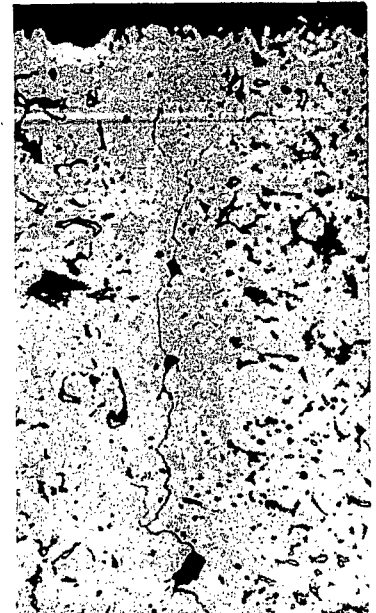
Figure 40.- Crack within
the tested
bearing material made of
alloy 30 I (bearing 933).
Magnification 200X.
